The Cardington Fire Test

Pal Chana and Bill Price, British Cement Association

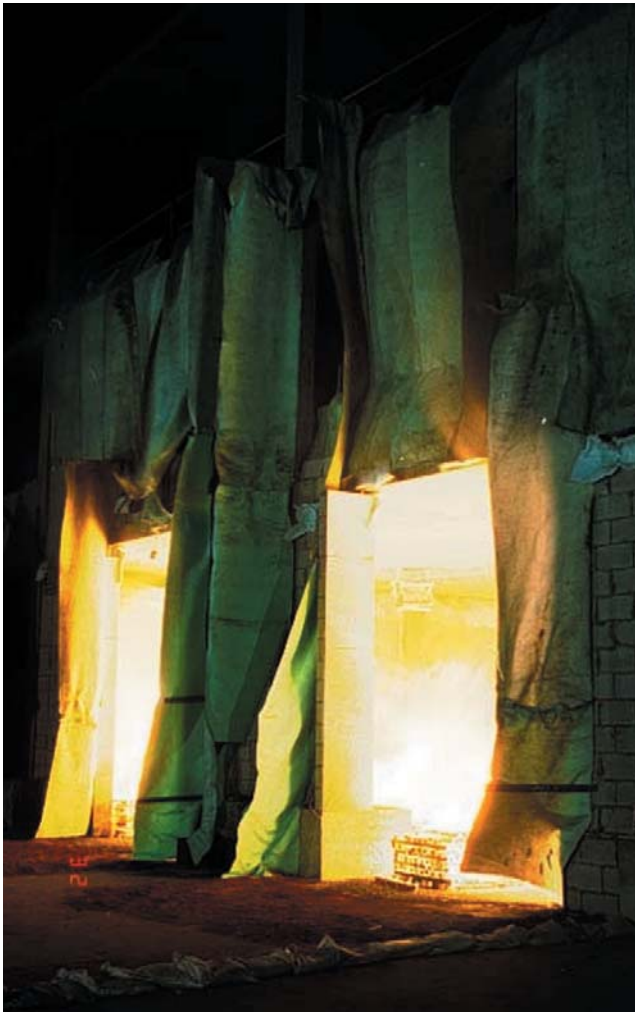
Figure 4: Fully developed fire.

The fire test was carried out on 26 September 2001. Figure 4 shows the compartment with the fully developed fire and Figure 5 demonstrates the time-temperature response.

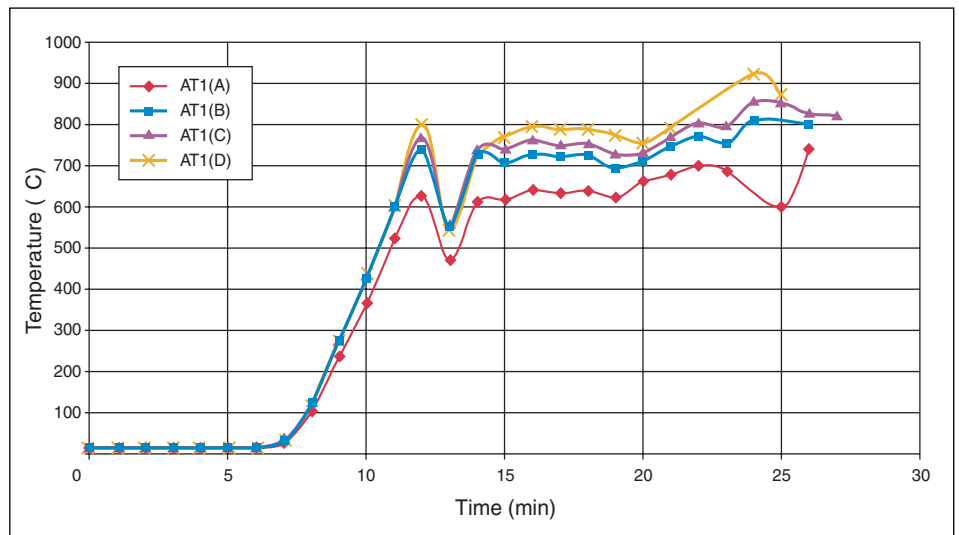
Figure 5: Recorded atmospheric temperatures.

Unfortunately, the fixings of the ceramic fire blankets sealing the compartment walls to the first floor slab failed about 25 minutes into the test due to concrete spalling around the fixings. This allowed the fire to escape from the compartment and melt the instrumentation leads, causing some data to be lost. At this stage the temperature in the compartment just below the soffit was 950°C.

2. The maximum atmosphere temperature recorded was 950°C, before malfunction of some instrumentation. This confirms the severity of the fire test and it is probable that higher temperatures occurred.

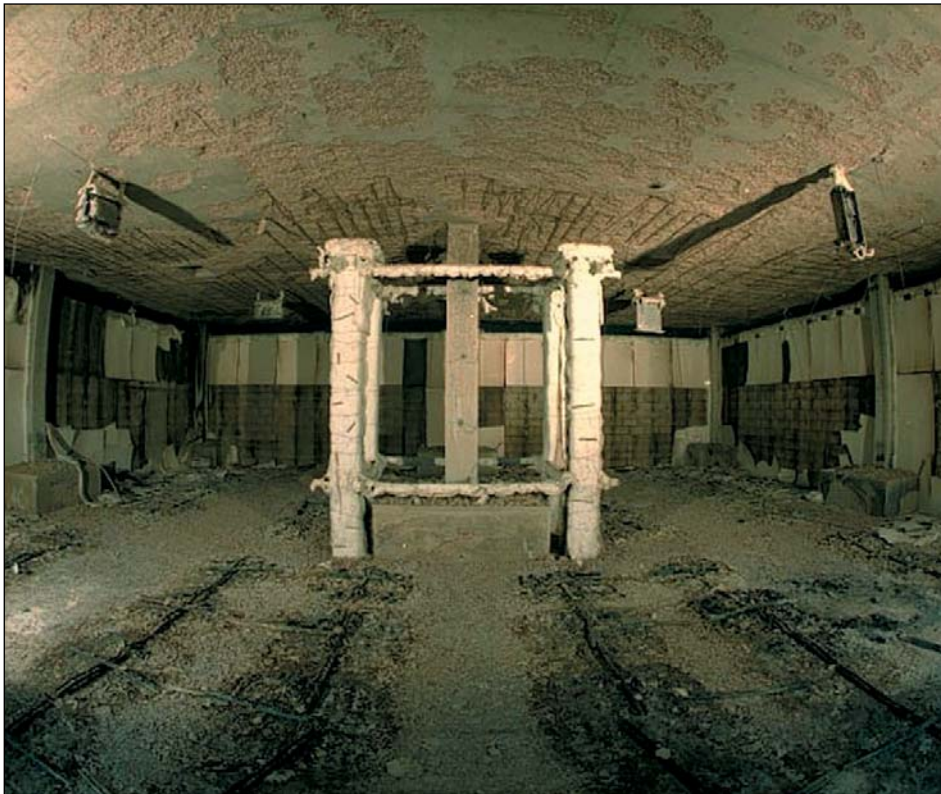
Figure 6: The extent of spalling after the fire.

Approximately 10 minutes after ignition, popping sounds were heard and small particles were seen spalling from the soffit, probably due to flint aggregate spalling. After a further three minutes, more violent (explosive) spalling was observed. At this stage, the atmosphere temperature within the compartment was over 800°C. It was noted that the larger concrete fragments falling from the soffit were suppressing the fire below. Violent spalling continued until, about 25 minutes after ignition, reinforcement in the slab began to be exposed. As the test progressed, large areas of reinforcement were exposed and concrete continued to spall. This continued (with decreasing severity) as the test proceeded to its conclusion. Figure 6 shows the extent of spalling at the end of the test.

3. Extensive spalling of the soffit to the first floor slab was observed but did not compromise the structural integrity of the floors under the imposed loads. The spalling was not surprising because:

- The concrete in the slab was much stronger (74MPa) than normal, which would have increased its likelihood of spalling; no polypropylene fibres were included in the concrete mix.

moisture content in the concrete was unusually high (3.8% by weight); this is higher than the 3% limit, below which spalling can be ignored, as specified in EN 1992-1-2(5). Typical moisture contents in a dry internal environment are below 2%.

- High compressive forces were induced in the slab when it was heated, which increased the likelihood of spalling.
 - Flint aggregates, which are particularly susceptible to spalling, were used in the concrete in the floor slabs.
4. The horizontal displacements of the floor slab due to thermal expansion were significant, a maximum horizontal residual displacement of 67mm being recorded. The lateral displacements of the external columns, due to the thermal expansion of the floor slab, induced some additional column moment. However, the thin columns showed no signs of distress and this is unlikely to be a problem in practice. Simple rules are being developed to check for this effect in design. UK concrete design practice requires minimum reinforcement ties to be provided at all connections, which leads to inherently robust construction.

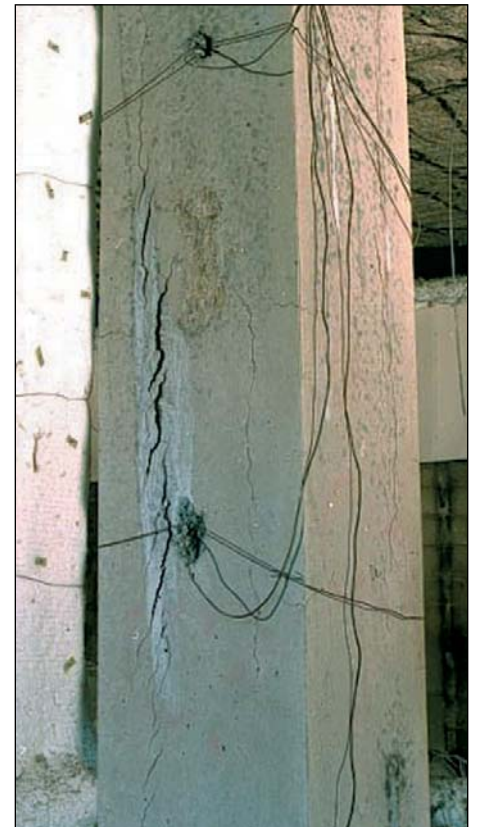
Figure 7: High-strength column after fire.

5. The high-strength concrete columns (103MPa), which contained polypropylene fibres, performed very well (Figure 7). Some non-violent corner spalling was evident, but this was considered to be insignificant to the columns' stability. Corner spalling can usually be repaired easily after a fire⁽²⁾.
6. The slab was able to carry the imposed loads with low residual vertical displacements (maximum 78mm). Observations from the test suggest that the floor slab was acting as a compressive membrane (Figure 8). This behaviour needs to be considered more fully in computer simulations, so simple design methods can be developed to incorporate the beneficial effects of compressive membrane action.

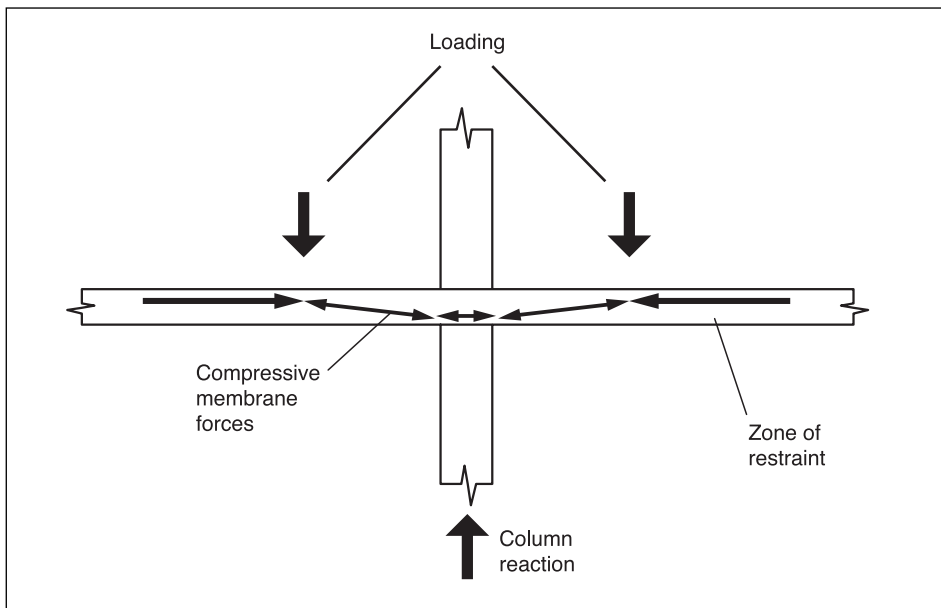
Figure 8: Compressive membrane action.

The results and observations from the Cardington test on a complete frame demonstrate that current codified methods are not based on a correct model of structural behaviour. In particular, membrane action occurred in the heated floor slab, which helped the building survive. The compressive membrane action seemed to support the heated floor slab, even though the concrete to the soffit spalled extensively, exposing large areas of the main flexural reinforcement.
