The Cardington Fire Test

Pal Chana and Bill Price, British Cement Association

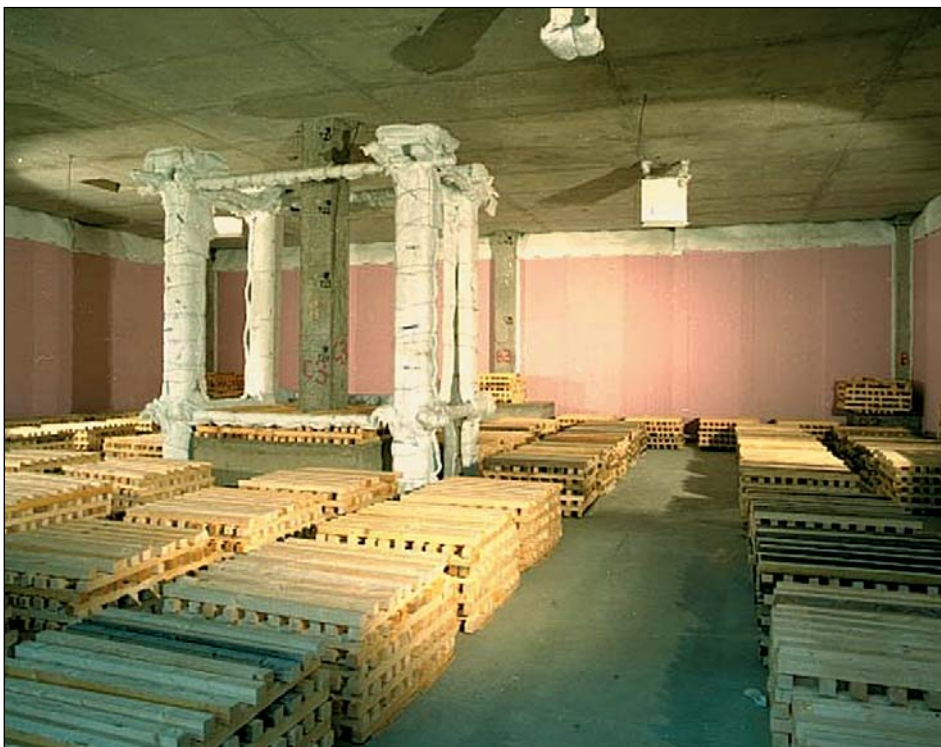
Figure 3: Fire compartment before ignition.

A safety cage was placed around the exposed internal column, but not actually in contact with the soffit of the floor slab. This was to support the floor slab if the column should fail during the test. Timber cribs were positioned in the compartment to provide a fire load of 40kg/m² (720MJ/m²), representing typical office fire loading to the British Standards (Figure 3).
