# Enniscorthy Fire – Viking Wharf Apartments

*Fire-stop details need to be more robust at top of party wall*

by Brian Ó Murchú

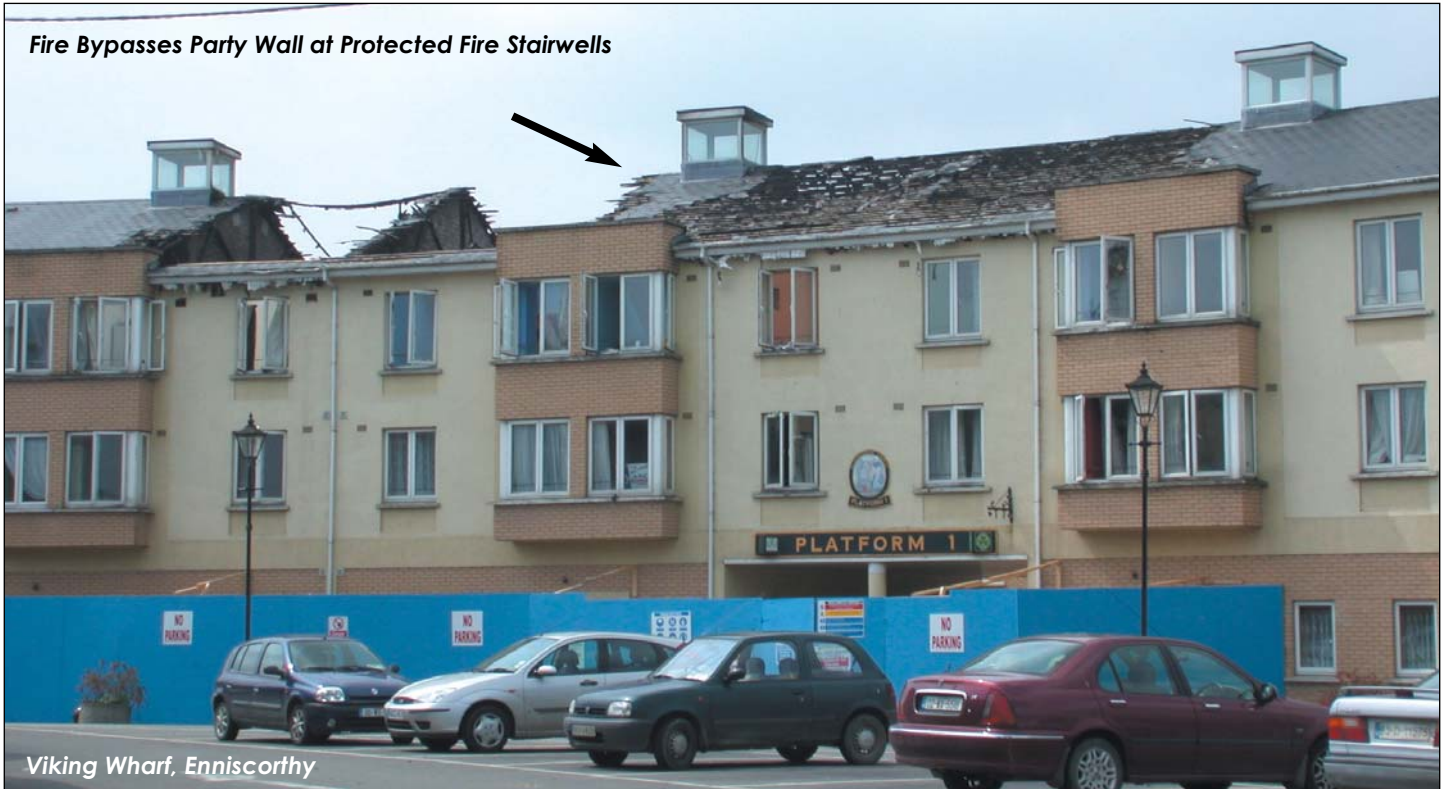
On 17th of May 2005 at approximately 9.00pm, a fire broke out within the roof/attic space of a block of 14 concrete built apartments in Enniscorthy, Co. Wexford. Despite the extensive nature of the fire, the building retained its structural stability and the concrete elements acted as an effective fire compartment. However, the fire stopping (if in place?) at the top of the party wall/roof abutment, failed to contain the fire, the result being the destruction of the adjoining properties and the obvious threat to the lives of about 70 people (mostly immigrants) housed within the building. Fortunately, damage was limited to property and there was no loss of life. Had the fire broken out at night time, rather than the evening time, the result may have been more serious. Indeed, the incident is reminiscent of recent fire tragedies in Paris in which many immigrants lost their lives.

The fire caused the trussed timber roof structure to collapse. This is a typical scenario with a positive aspect – in that the collapse of the roof can vent the fire vertically, reducing the internal temperature and curtailing the horizontal spread of fire. This was shown

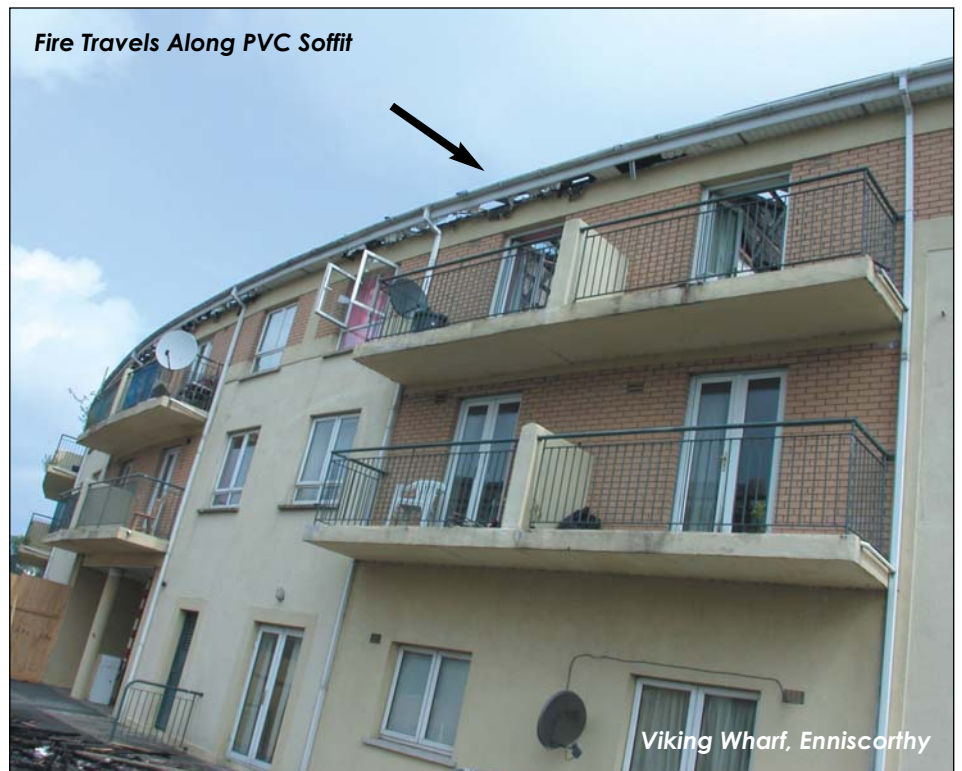
**Parapets Offer Greater Fire Protection**

prevented from spreading to adjoining properties and to fire escape areas – i.e. protected stair wells. In the case of the Enniscorthy fire, it is clear that the fire stopping at the top of the party wall was ineffective (if at all present) and did not prevent the spread of flame to the adjoining properties. Of greater concern is the fact that the fire was able to bypass the party walls at protected stairwells – effectively compromising the area which is specifically designed for occupants to escape and for access for fire and rescue personnel.

Based on our own observations and discussions with fire specialists, it would appear that a more fail-safe method of

detailing is required at the top of party walls. The failure of such party wall abutments are a known risk and this needs to be addressed. Fortunately, effective and economical engineered design solutions already exist and these are well known to many builders, but there is a need for this more technological approach to be supported at official level. The Irish Concrete Federation would certainly welcome and support such an approach.

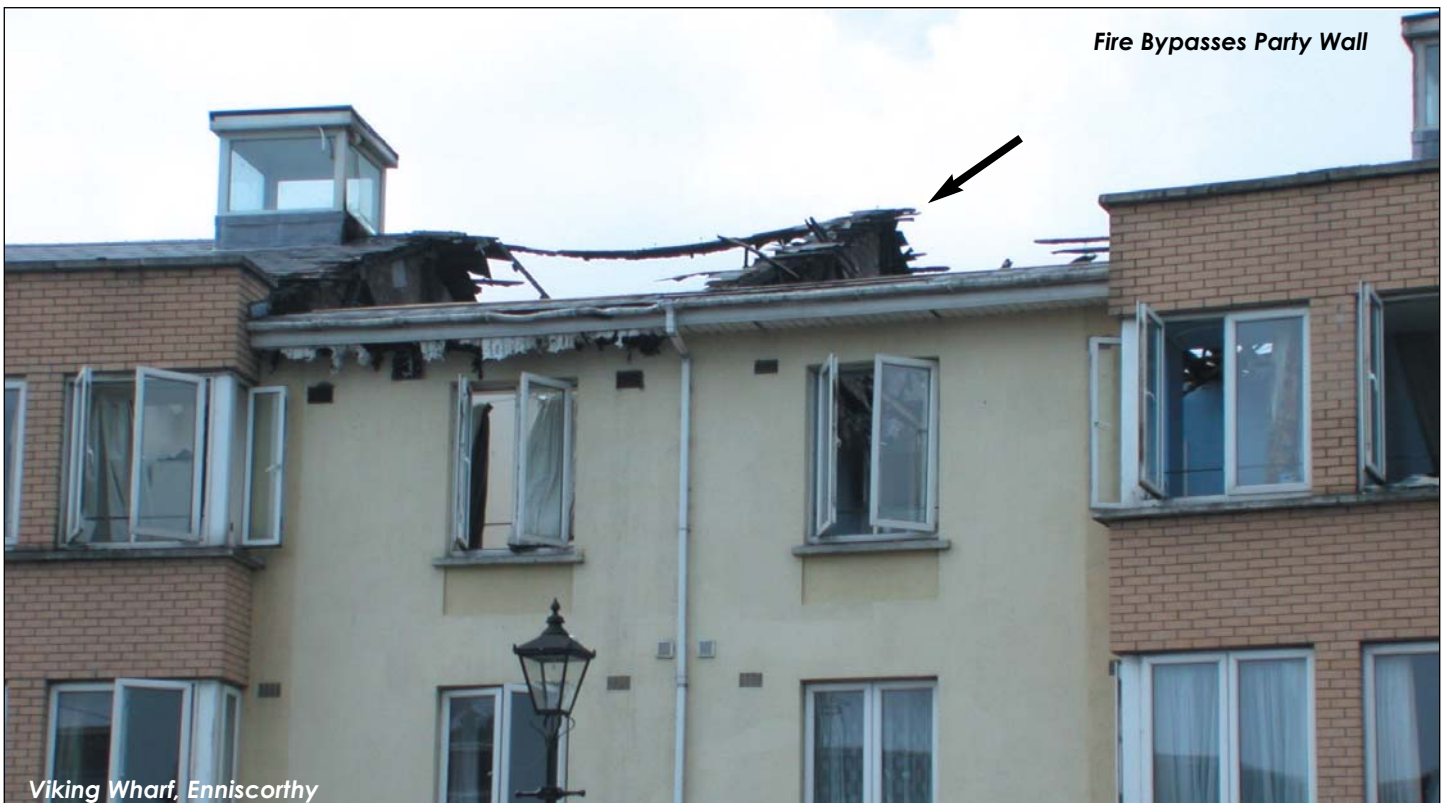
Viking Wharf, Enniscorthy

In the case of the Enniscorthy fire, the spread of flame across the top of the party wall compromised the fire compartmentation. The effect of this was that firemen were required to hose the entire roof area, flooding all apartments right down to ground level. The result was that all the apartments had to be evacuated and refurbished at significant cost to the insurers. Had the details at the top of the party wall been effective, the fire would have been contained in a small area of the building and damage to property and inconvenience to occupants may have been far less. Because it was concrete built, the apartment block was re-buildable. Had the fire taken place in a lightweight frame construction, water damage alone would have required that the whole inner structure be removed and complete demolition would have been the most likely outcome, at substantially greater cost to the insurers.

**Fire Bypasses Party Wall**
